TECHNICAL SERVICE BULLETIN

Torque-On-Demand (TOD) Transfer Case - Grinding/Clicking/Ratcheting Noise From Front Wheel Area

20-2307

15 October
2020

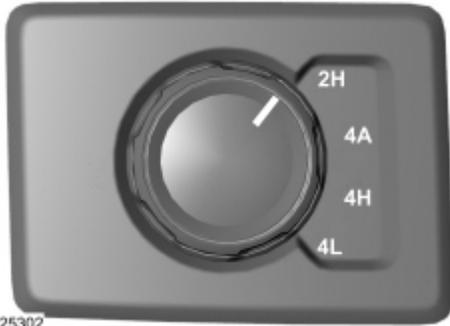
Figure 1 - Example of MSS with 4A selection

1. Does the vehicle have a mode select switch (MSS) that includes a 4-wheel auto (4A) option? (Figure 1)
 - (1). Yes - proceed to Step 2.
 - (2). No - this article does not apply. Refer to the Workshop Manual (WSM) for normal diagnostics.

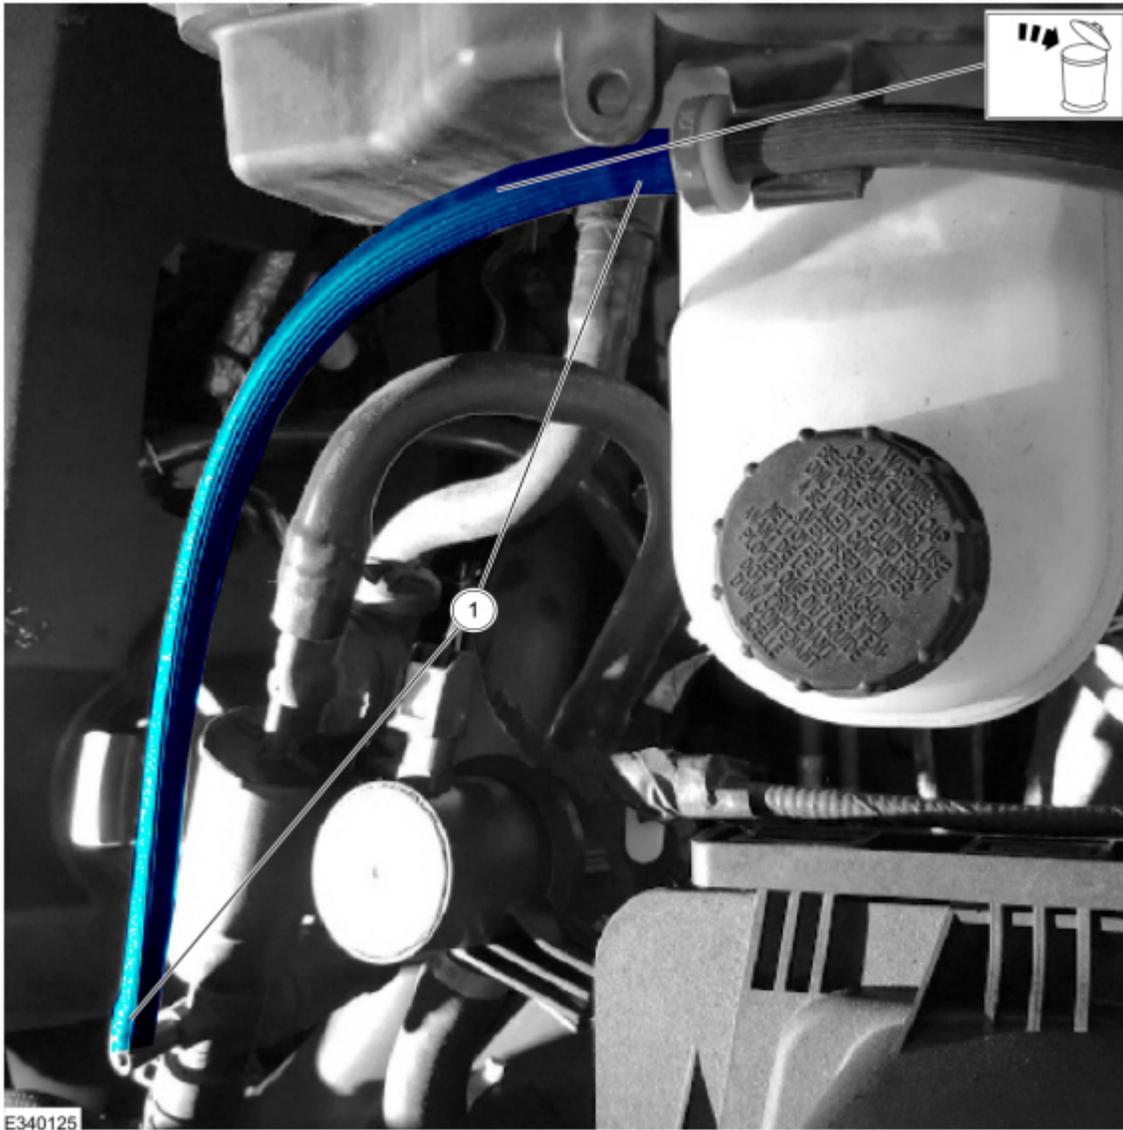
Figure 2

2. Locate the vacuum supply line between the source vacuum and the IWE check valve. Refer to WSM, Section 308-07A. (Figures 2-3)

3. Remove the vacuum supply line.
4. Install the vacuum caps at the IWE check valve and the vacuum source.
